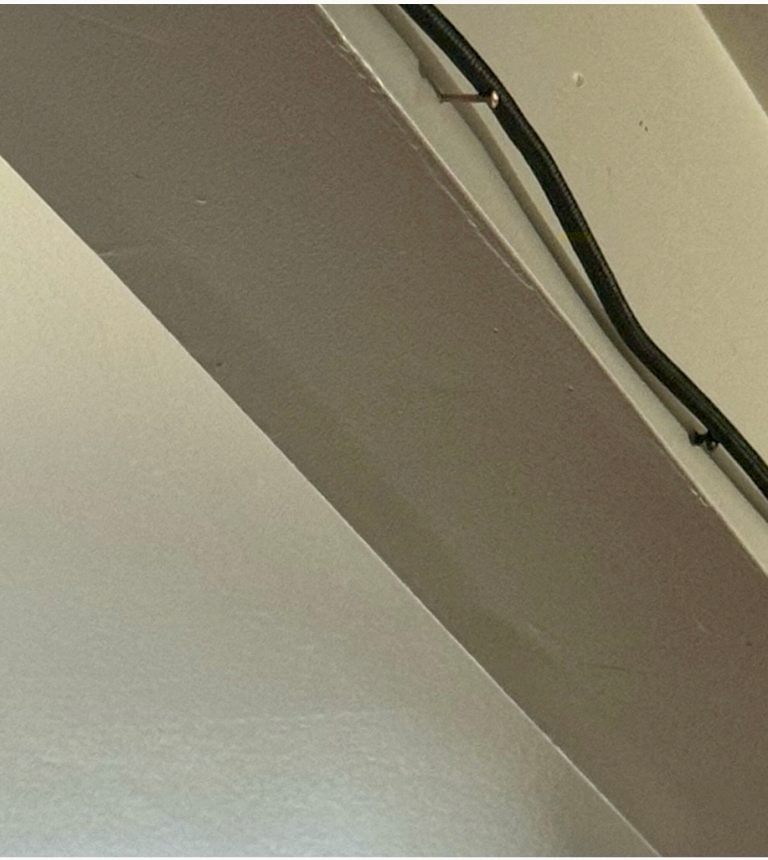
BEAM #1

BUBBLING PAINT INDICATES TRAPPED MOISTURE. YOU CAN SEE THE 1” ROT/SHEET ROCK COVERAGE ALONG THE LEFT SIDE OF THE BEAM.

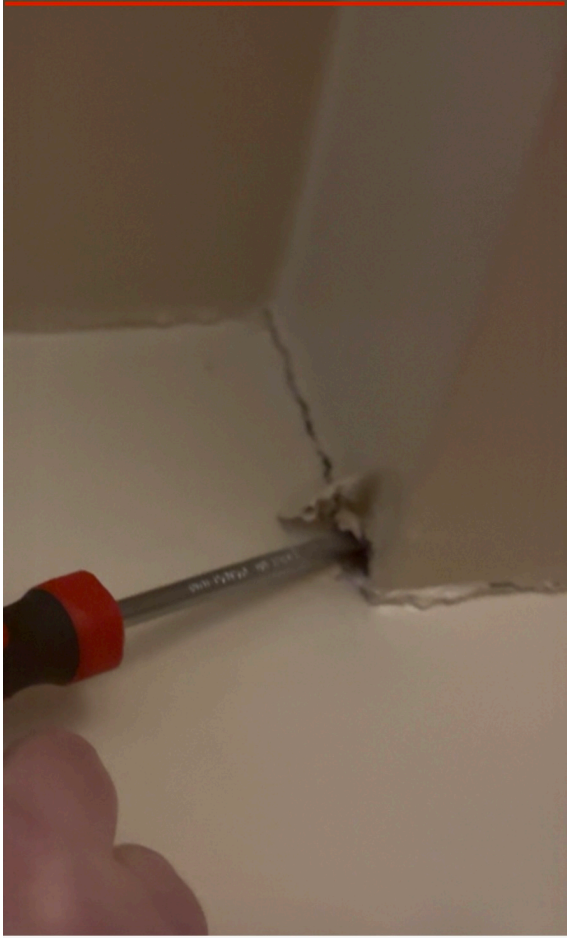
BEAM #3 END #2

1” MARK ON SCREWDRIVER
